# Waterman Lake Dam - Main Dam Study

## Seepage Investigation & Recommendation Report

March 2022

Smithfield, Rhode Island

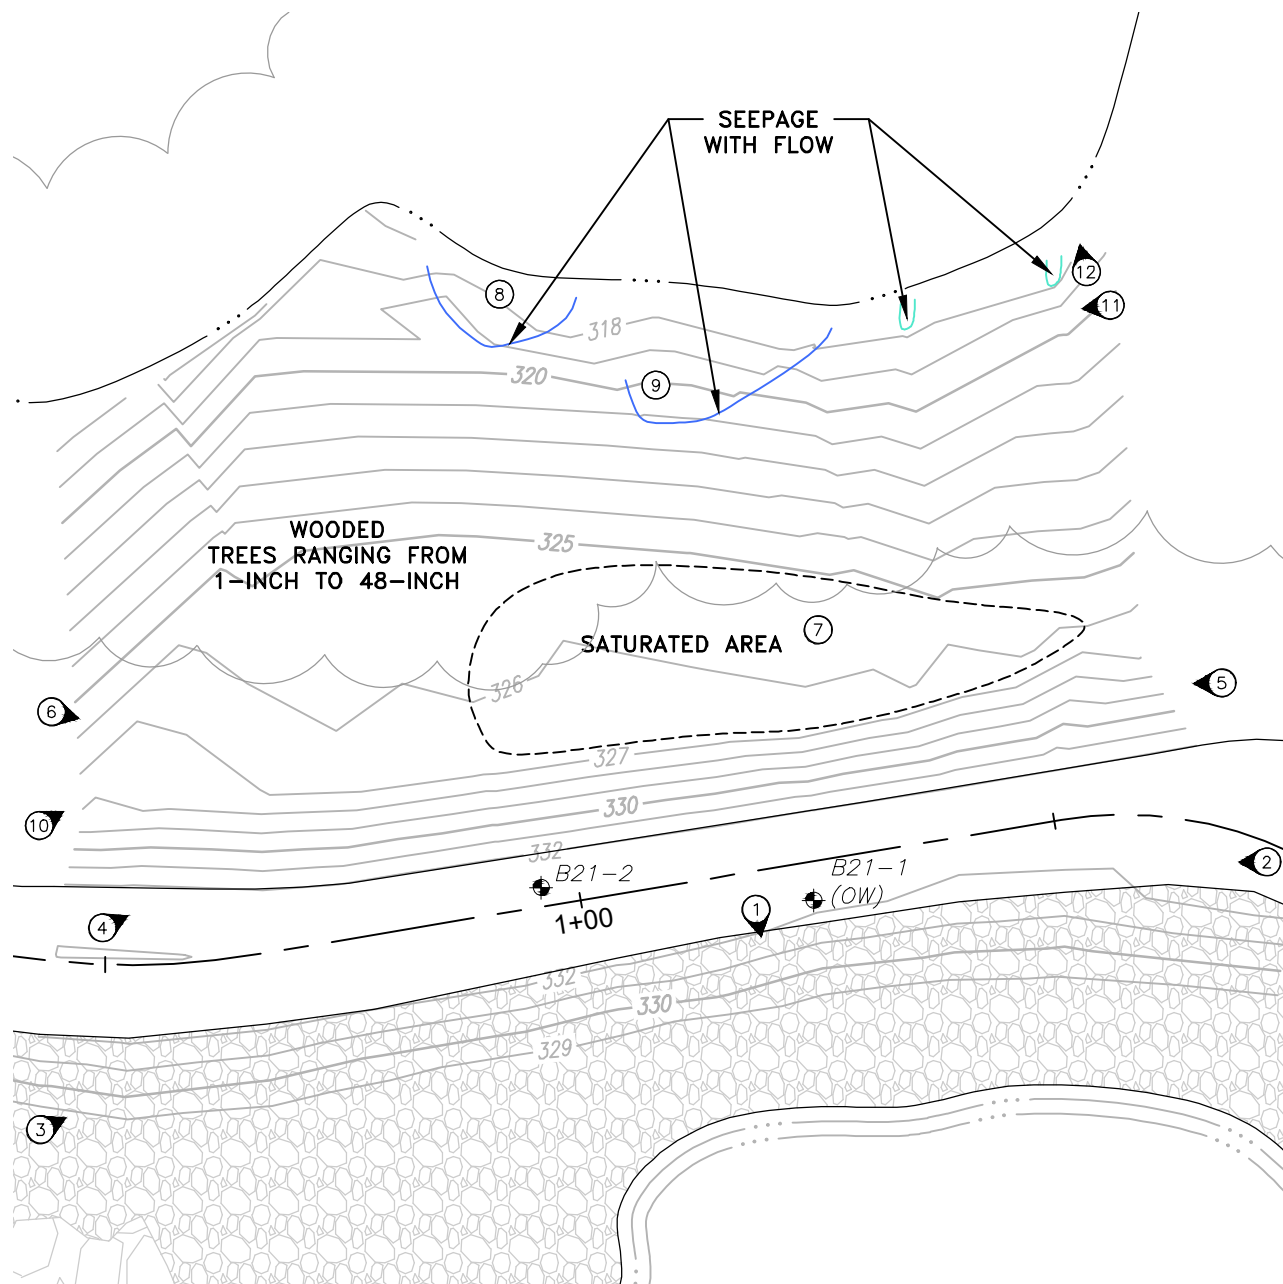
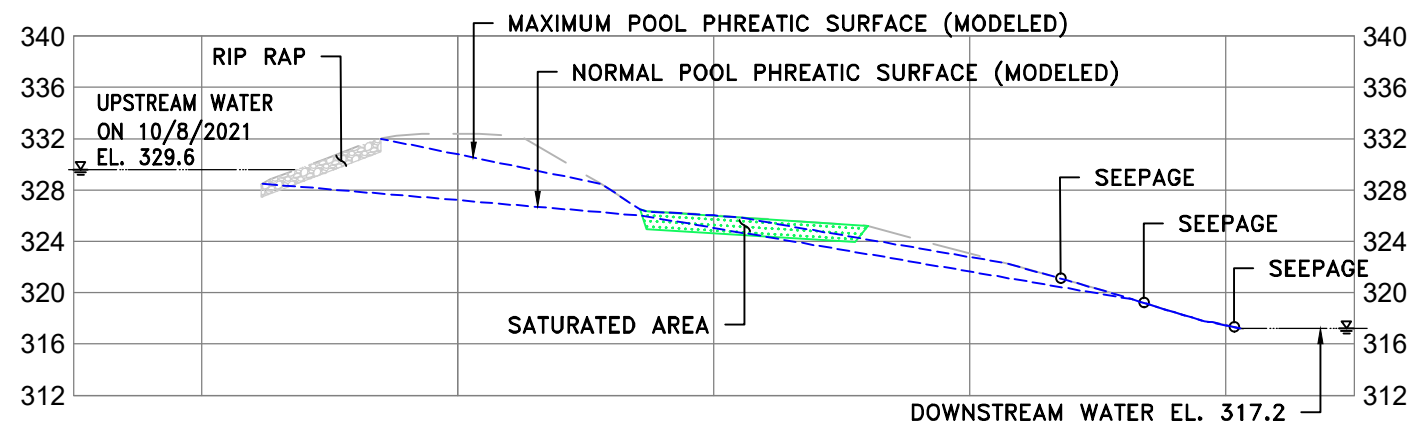
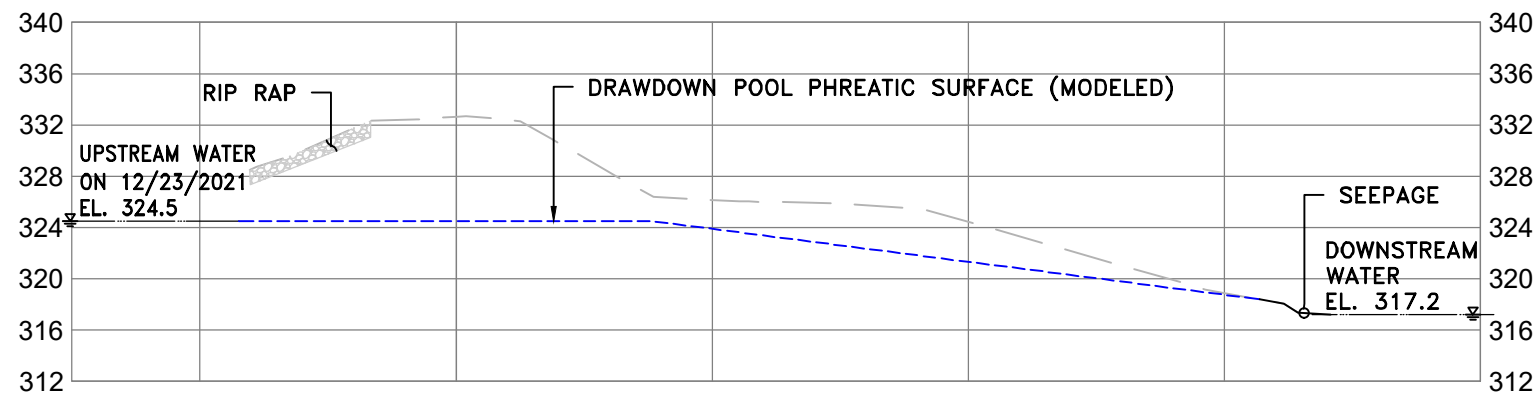
**EXISTING STUDY SECTION**

- Active seepage and saturated ground were noted along the downstream toe and along the slope of the natural terrain downstream of the dam.
- Seepage was observed to have heavy iron oxide staining and evidence of sediment transport.
- The downstream slope of the dam is steep with soft surface soils.
- Numerous trees ranging between 12 and 36 inches in diameter were noted along the downstream toe along the native ground and along the downstream slope of the native ground. Seepage was observed discharging from beneath the root systems of numerous trees throughout the downstream area.

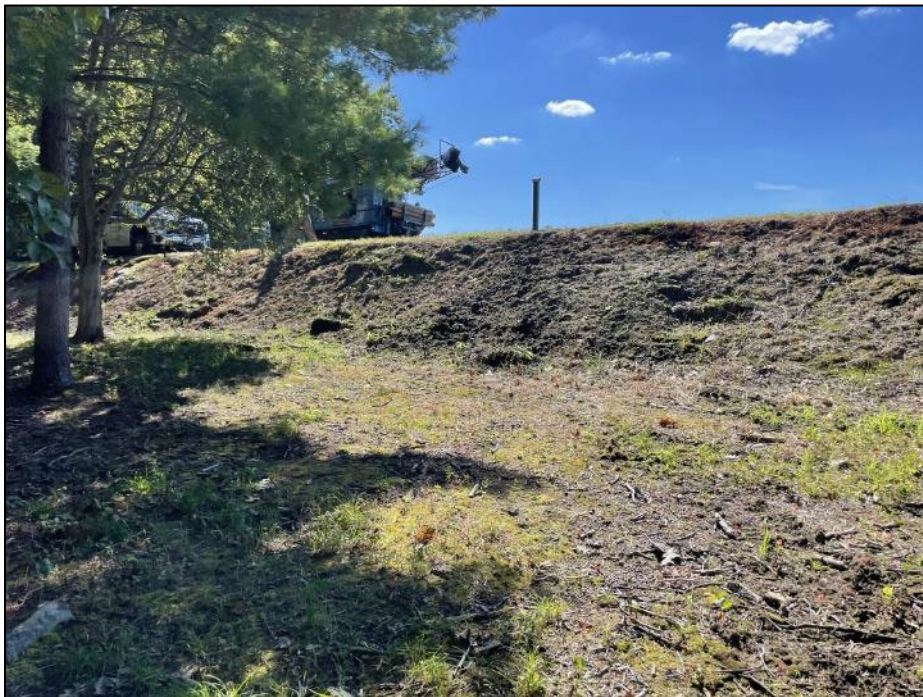
Photo No. 6.: Overview of the study area downstream slope from the toe of the dam looking right. Note the steep slope and uneven surface throughout.

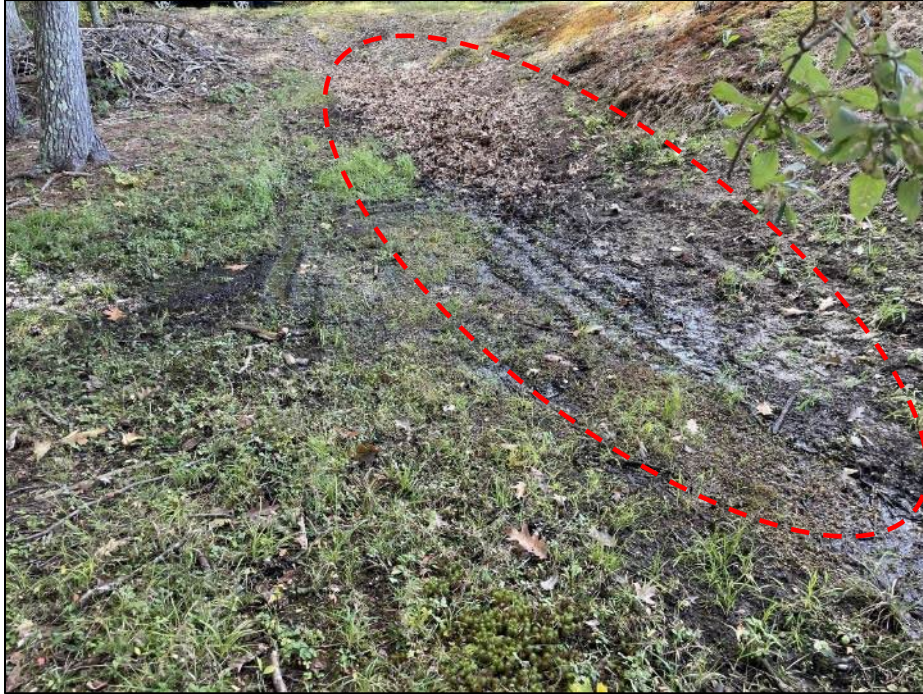
Under normal pool conditions, soils at the toe of the dam embankment were saturated and areas of seepage were observed breaking out from the downstream slope above the elevation of the tail water. Several areas of concentrated seepage were present in close proximity to the root systems of the many trees along the

Photo No. 7.: Saturated area along the downstream toe of the dam (atop the native terrain) during normal pool (looking right).

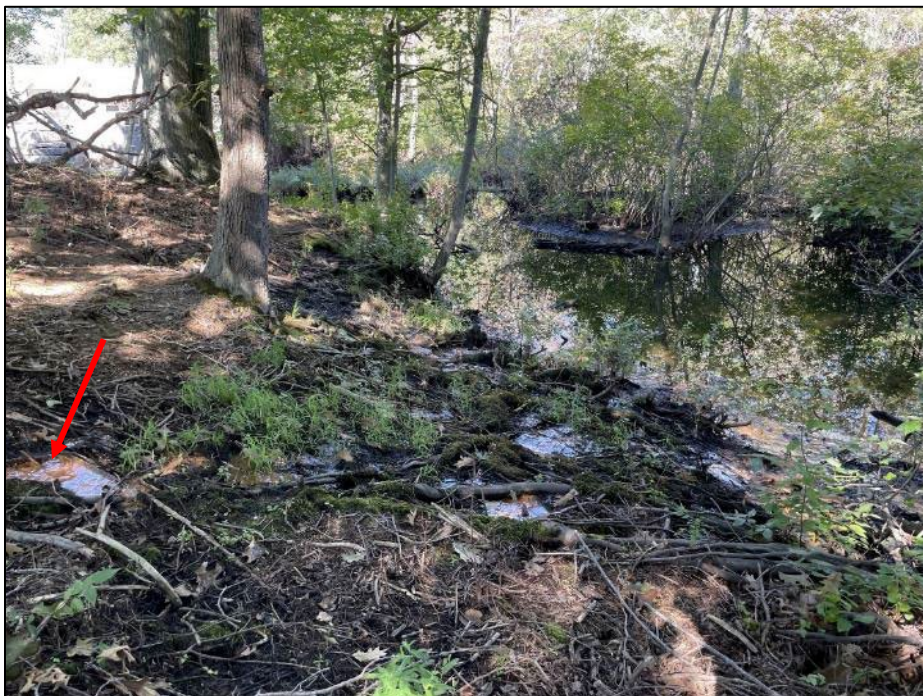
downstream slope of the native terrain. Seepage was generally flowing clear; however, iron oxide staining and flocculent was present at all seepage locations. Sediment present in the seepage areas appeared to be old, as the iron oxide staining and flocculent was developed over the material; however, sediment was present indicating the potential for internal erosion to have occurred. It was unclear if the sediment deposition was merely the result of localized erosion at the point of seepage breakout, or if the sediment was sourced from deeper within the embankment/native terrain as a result of internal erosion. While factors of safety against piping within the SEEP/W model were calculated to be greater than 2, there is the potential that localized conditions, such as, soils loosened from tree roots or non-homogenous soils could result in areas where the factor of safety could be less than 1, causing internal erosion to develop locally.

Photo No. 8.: Active seepage breakout with iron oxide staining along the downstream toe of the native terrain.

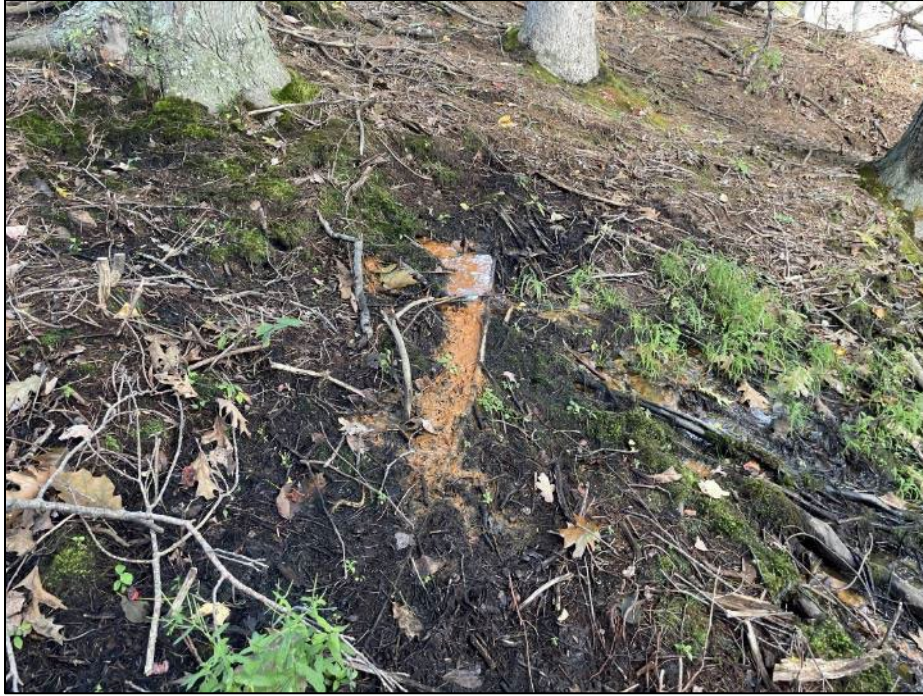
Photo No. 9.: Closer view of the seepage at the downstream toe of the native terrain.

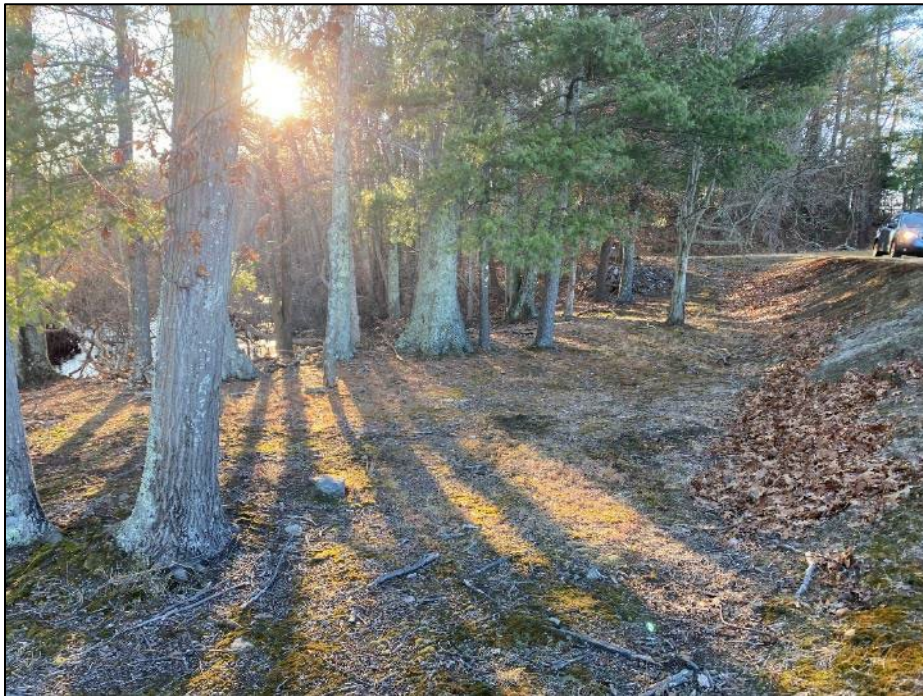
1. **Tree Clearing Program:** Based on observations made during the various site assessments it is apparent that the mature tree growth along the native terrain downstream of the dam is affecting the seepage patterns through the dam. Seepage breakout at several locations was concentrated beneath the roots systems of nearby trees. While root systems of trees do provide a degree of surface erosion protection, they cause detrimental effects to a dam or other water retaining structure, such as locally loosen soils as a result of rotting roots, displace soil if the tree is subjected to high wind loading, and loosen soils as the root systems pull against the soil matrix to stabilize the tree. Once soil along a root system has loosened, the space between the root and the intact soil becomes a preferential pathway for water to travel, leading to increased seepage and potentially piping erosion.

Photo No. 10.: Overview of the downstream area of the dam (native terrain) after drawdown. Note trees ranging between 4-inch to 36-inch diameter growing atop the native terrain and in close proximity to the dam embankment.

Pare recommends clearing trees, brush, and other unwanted vegetation from the native terrain between the dam and the downstream tailwater. Stumps and root systems larger than 0.5 inches in diameter should be grubbed within the footprint of the slope. Resulting voids should be filled with approved material and compacted in lifts, no larger than 12-inches thick, to subgrade for the specific treatment (i.e. loam and seed, riprap, etc.). Once cleared, grubbed, and backfilled, disturbed surfaces should be covered with loam and seeded. Completion of the work, especially grubbing, during a normal or elevated pool level could result in uncontrolled seepage and internal erosion of the native foundation soils and a rapid loss of the dam. Given the observed seepage, this work should only occur during the winter drawdown under the observation of an engineer practiced in dam engineering.

**Recommendation #1 – Tree Removal:** Pare recommends that actions be promptly taken by the Owner to remove the trees from the downstream slope and native terrain downstream of the dam. Trees pose two types of risk to an embankment:

In discussions with the CPWL, budgetary constraints may limit the extent to which they can remove the trees and grub the associate root balls. Therefore, to remove the immediate risk, it is recommended trees be cut such that 2 to 3 feet of the stump remain. This will allow for the easy identification of cut trees during future grubbing work and allow for a future grubbing Contractor the option of removing the tree and associated root balls by anchoring to the tree stump. *Cutting of the stump flush with the ground surface or grinding the stumps below the ground surface IS NOT recommended for a delayed grubbing program, as these actions may limit the ability to locate previously cut trees and will limit the options available to future contractors to adequately grub the root systems.*

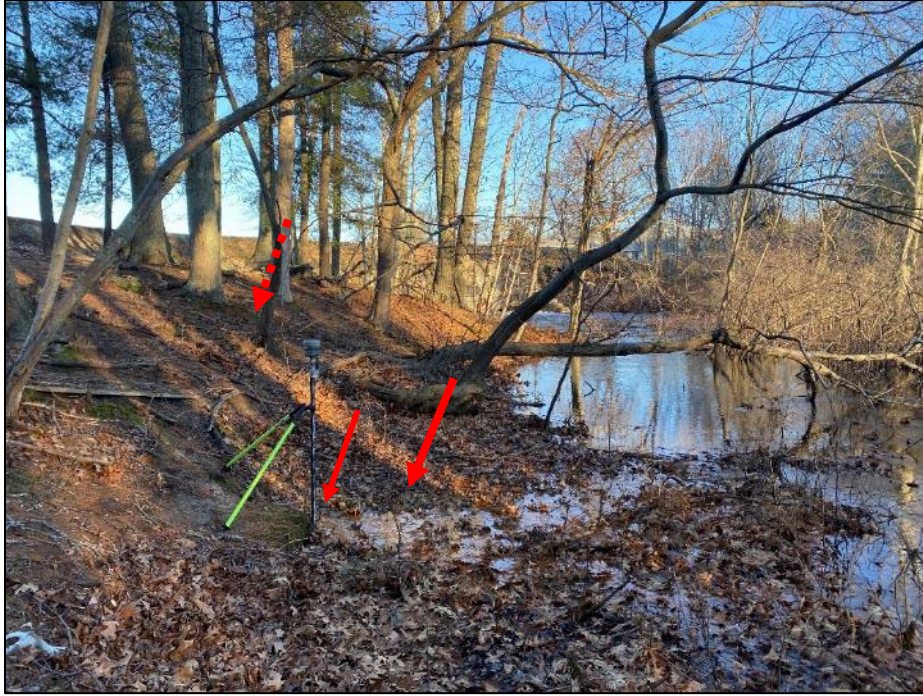
Photo No. 11.: Seepage at the downstream toe of the native terrain after drawdown (solid arrows). The dashed arrow indicates the approximate location of the seepage from the slope during normal pool levels (see Photo No. 9)
